Seismic Evaluation of
**San Francisco Sherriff's Department
County Jail - Building CJ-6**

One Moreland Drive
San Bruno, California

Prepared by:
Structural Engineering Section
Infrastructure Design and Construction Division
Department of Public Works
City and County of San Francisco

November 2013

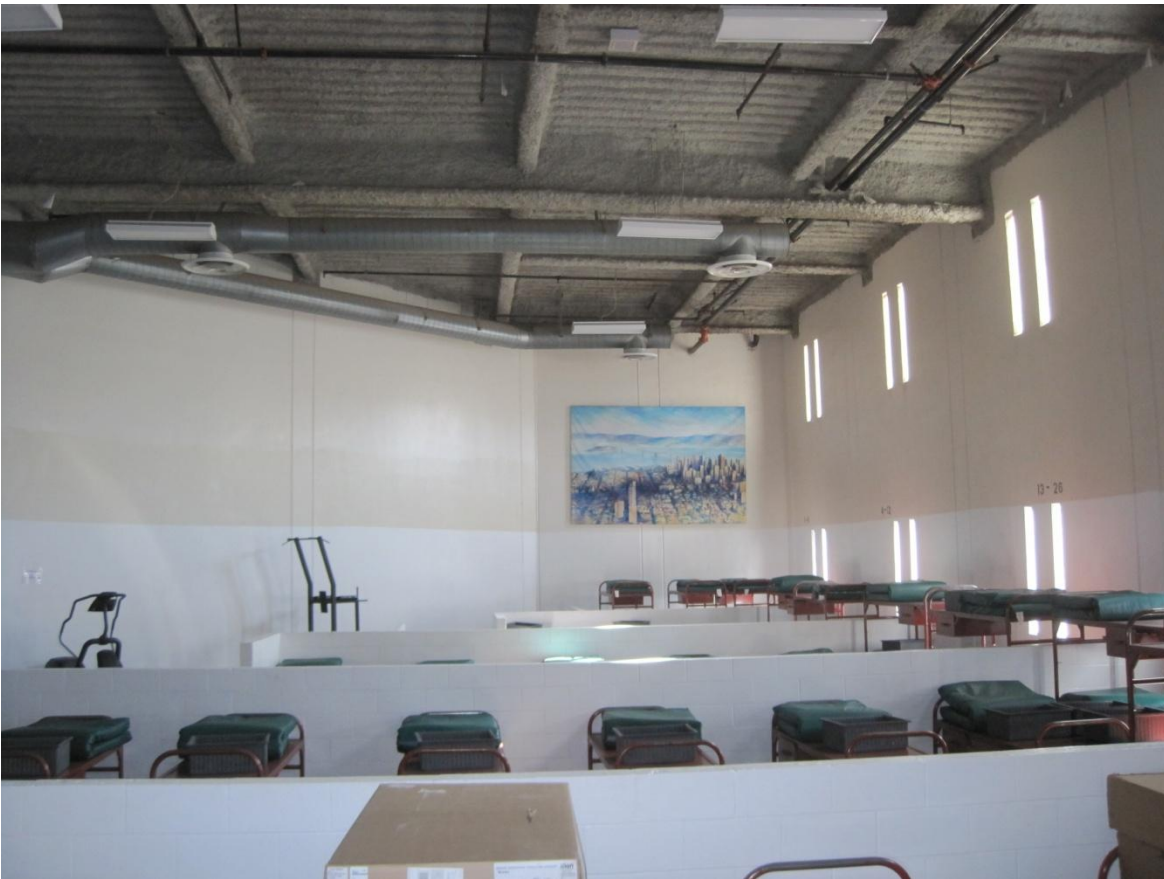
Figure 2 – Typical Interior and Exterior Tilt-up Concrete Walls

Based on our evaluation of the existing building, CJ-6 appears to have been built in substantial conformance to the design drawings. Designed and built in 1988, the building appears to be in fairly good condition. There are no major cracks in the concrete shear walls and no signs of settlement can be observed. Per the facilities representative, some minor repair to surface cracks and stucco was done after the 1989 Loma Prieta earthquake. There were no post earthquake damage reports available to review.
