April 9, 2026

# Zuckerberg SF General (ZSFG) Campus Project Annual Updates

Joe Chin, PE  
Program Manager

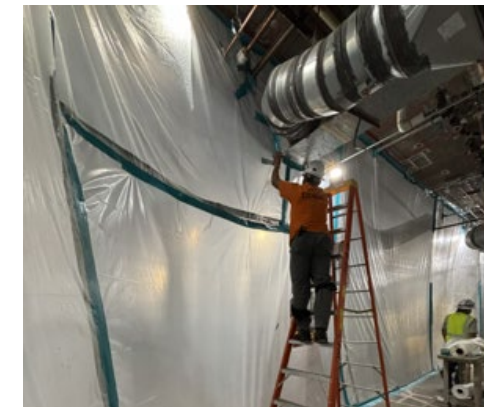
Typical IC barrier setup

**Infection Control (IC) Requirements.** Stringent infection control (IC) requirements mandate detailed written plans and efforts to set up and maintain negative pressure containments to isolate the workspace from the rest of the hospital during construction and oversight by DPH Environmental Health and Safety

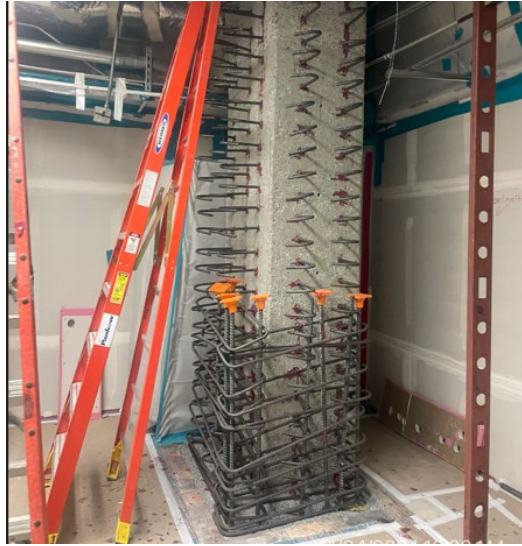
Existing Concrete Column Enlargement

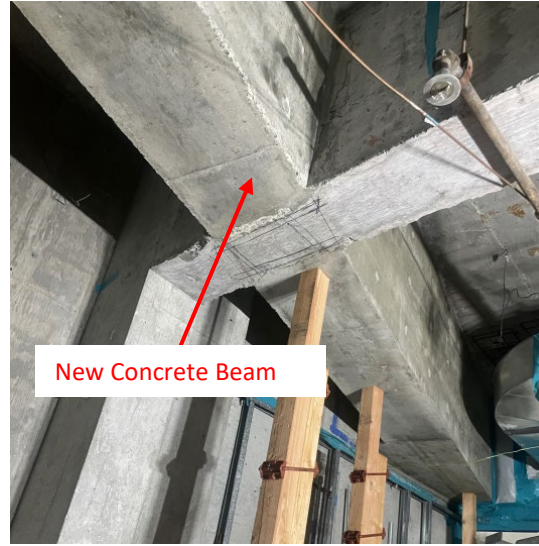
Added Concrete Beams

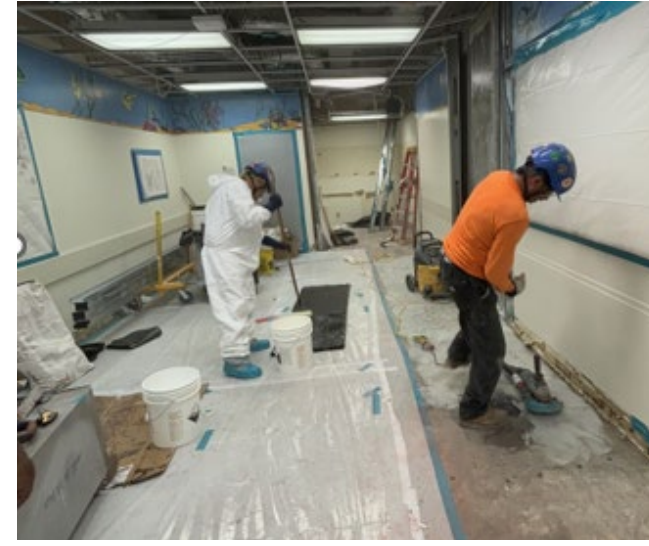
Fiber Reinforced Polymer (FRP) Strengthening Wraps

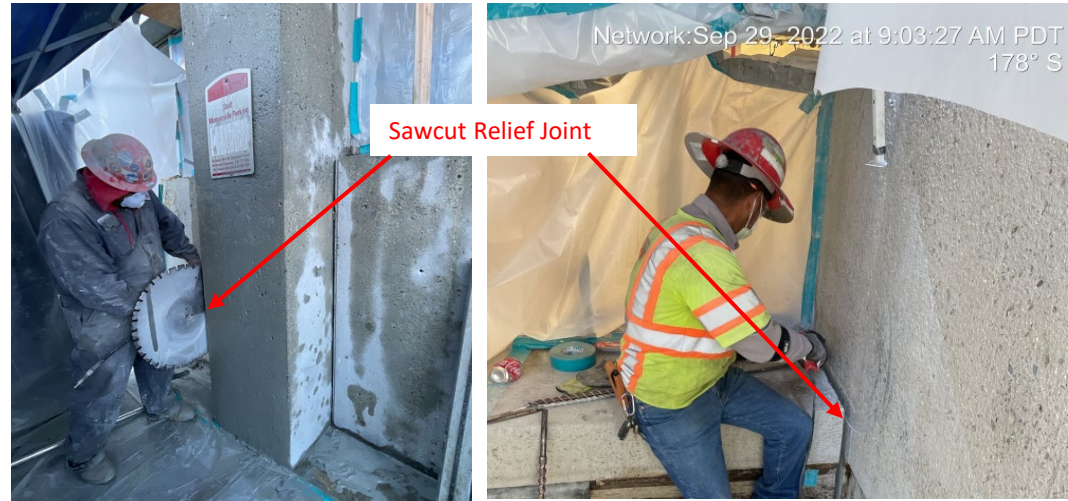
Exterior beam spandrel sawcut and caulking

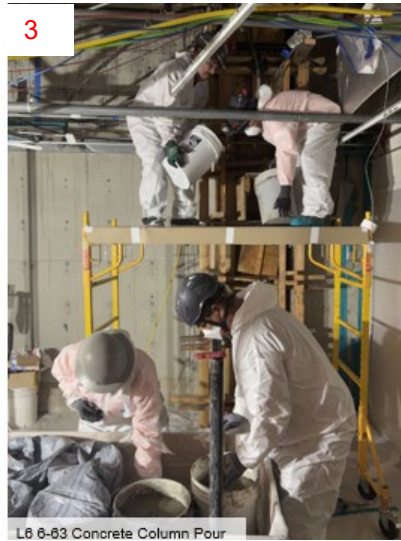
Photos #1-4: Construct new steel beam and column and new concrete column

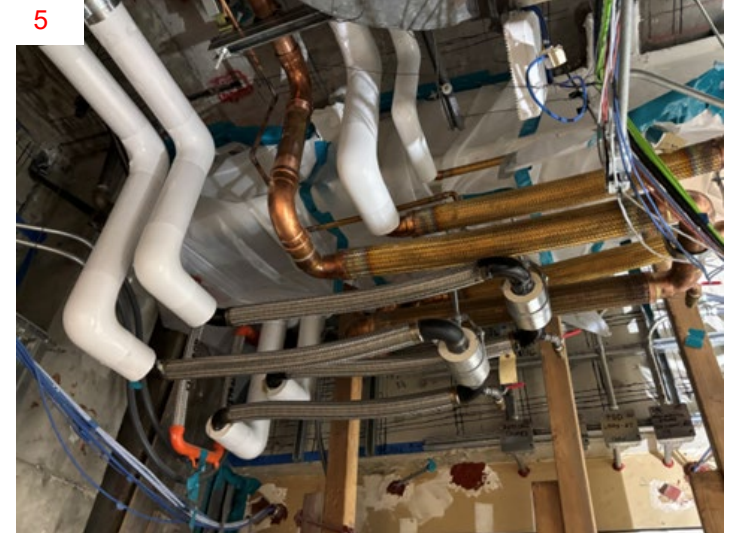
Photo #5: Install new flexible connections for all existing utilities

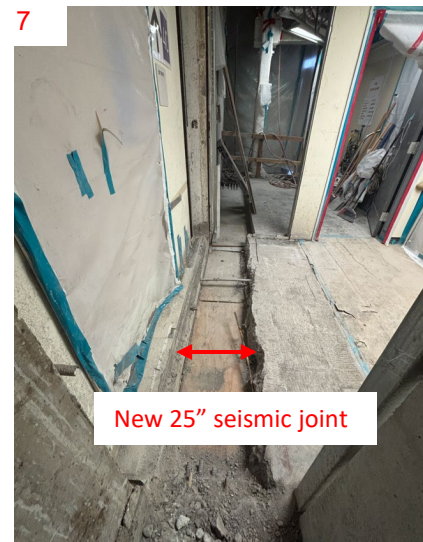
Photos #6-7: Chip out existing column and slab to create new seismic joint

Please be advised that noisy work involving concrete chipping will resume at the 3M seismic joint this Saturday, 2/14, from 8:00 AM – 4:00 PM and next Monday, 2/16 from 8:00 AM - 9:00 PM
