#### **SUMMARY OF FINDINGS**

### **FUSARIUM WILT**

#### (Fusarium oxysporum f.sp. canariensis)

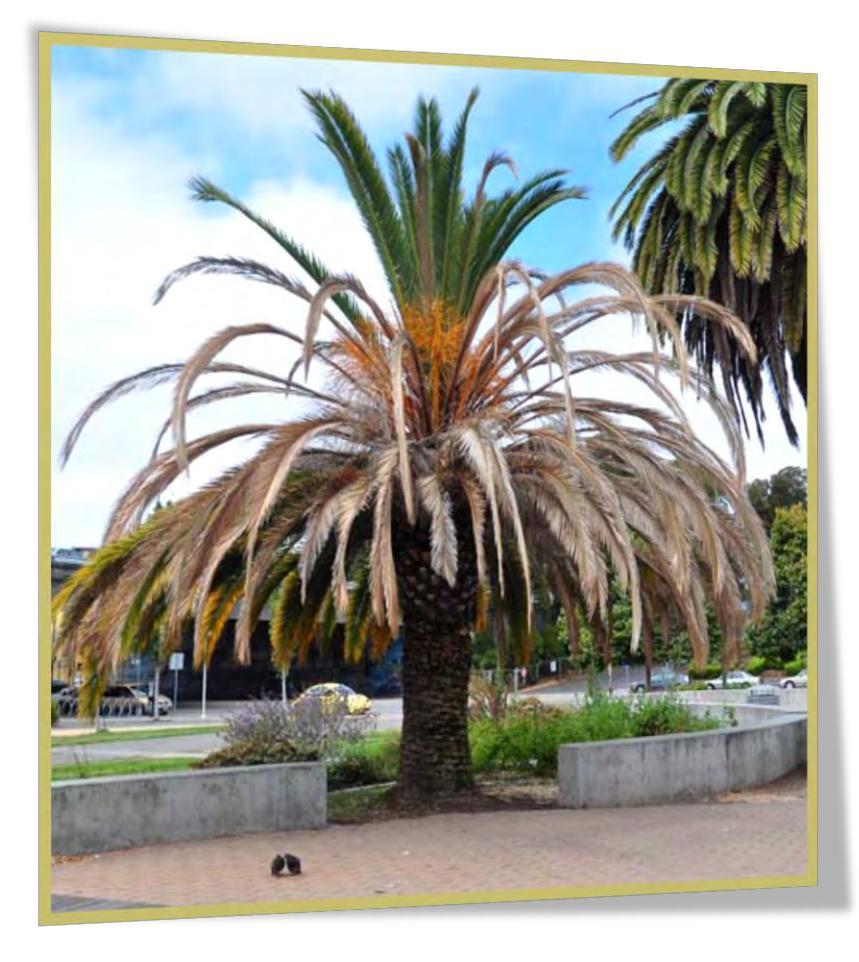
- A particularly aggressive strain of the fungus that attacks Canary Island date palms
- Disease causes loss of function of the water conducting cells within the plant
- Unknown whether it causes cell dysfunction through physical plugging, enzymatic action and/or fungal toxin action. But likely to be one or more of the above

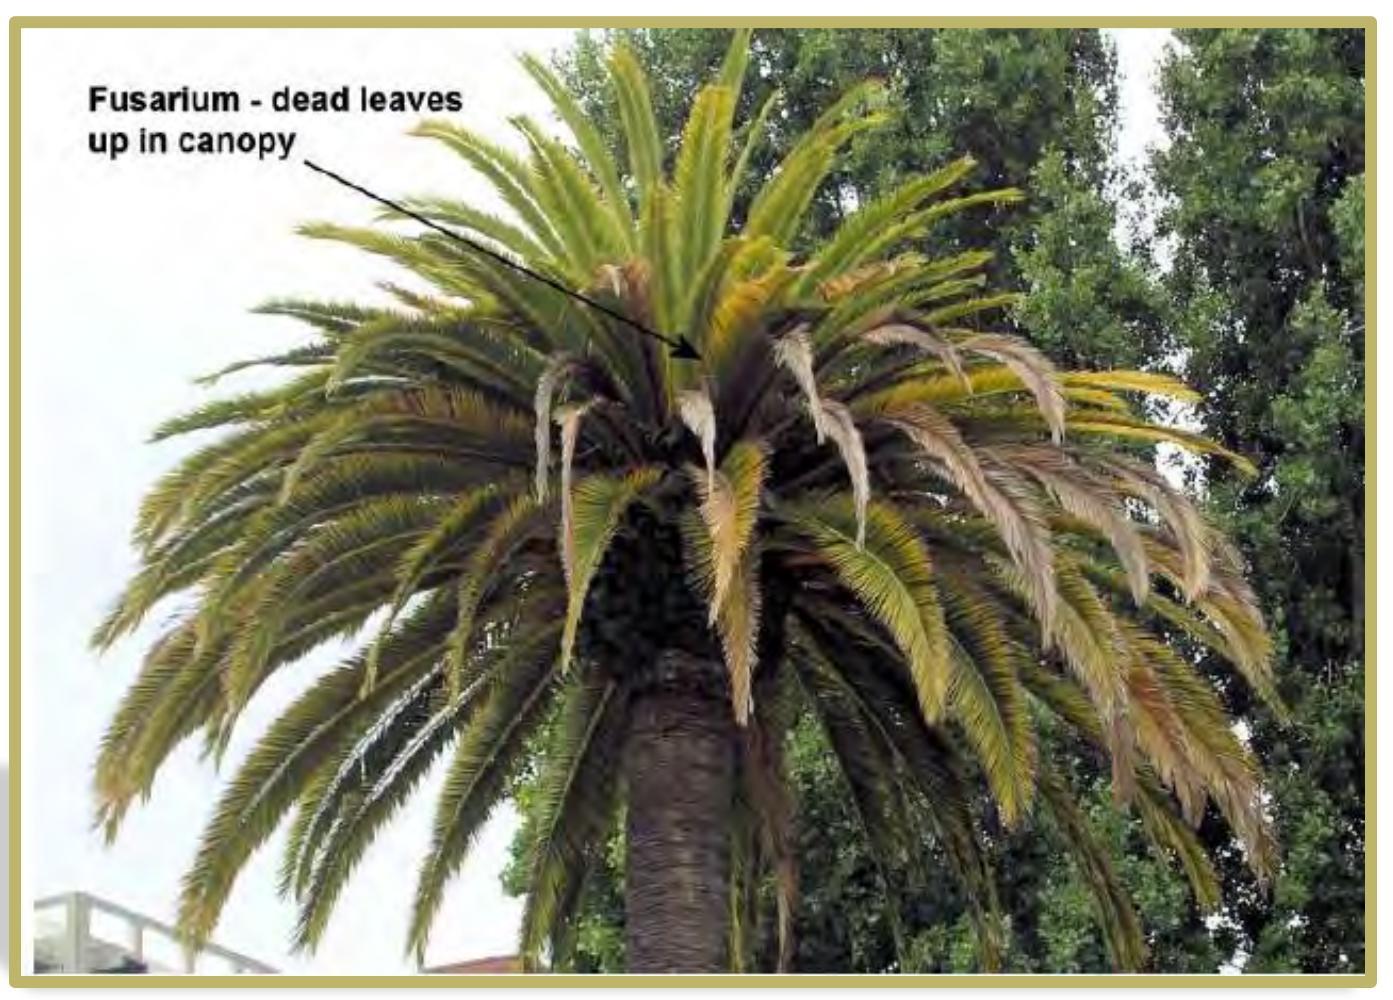
- Exhibit reduced vigor during early disease onset
- Sometimes, first symptomatic leaf is in the mid-canopy

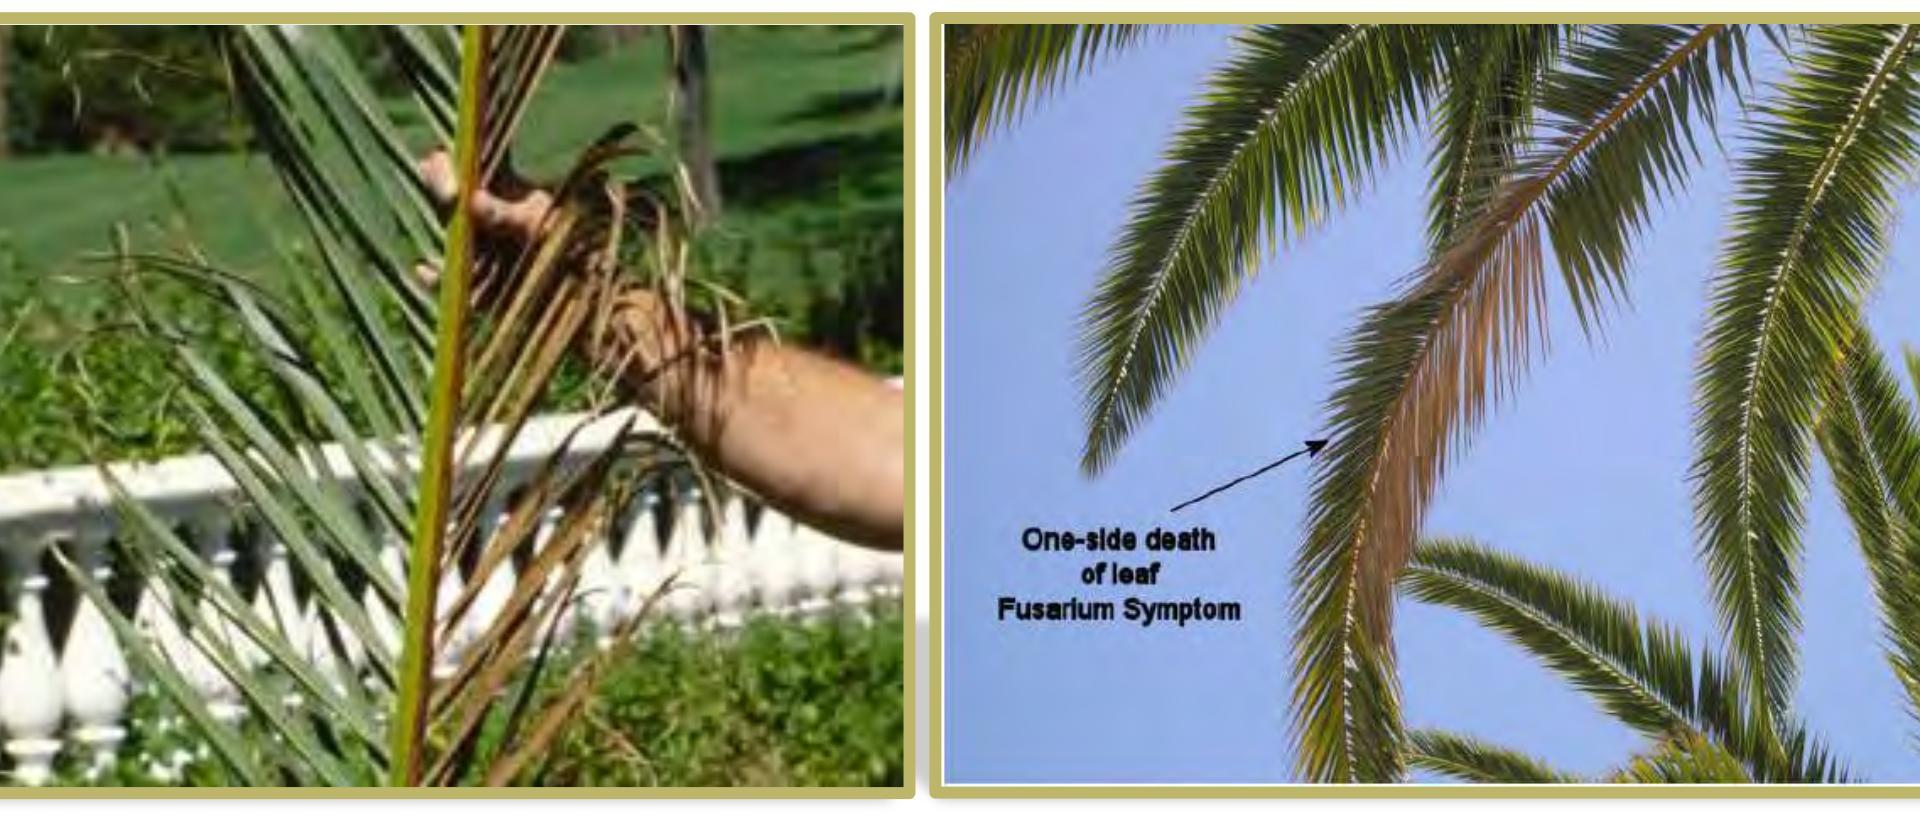
#### One-sided distribution of the disease. This is not diagnostic, but is very indicative.

- Fronds die in a one-sided manner
- Decline on the tree may also seem one-sided

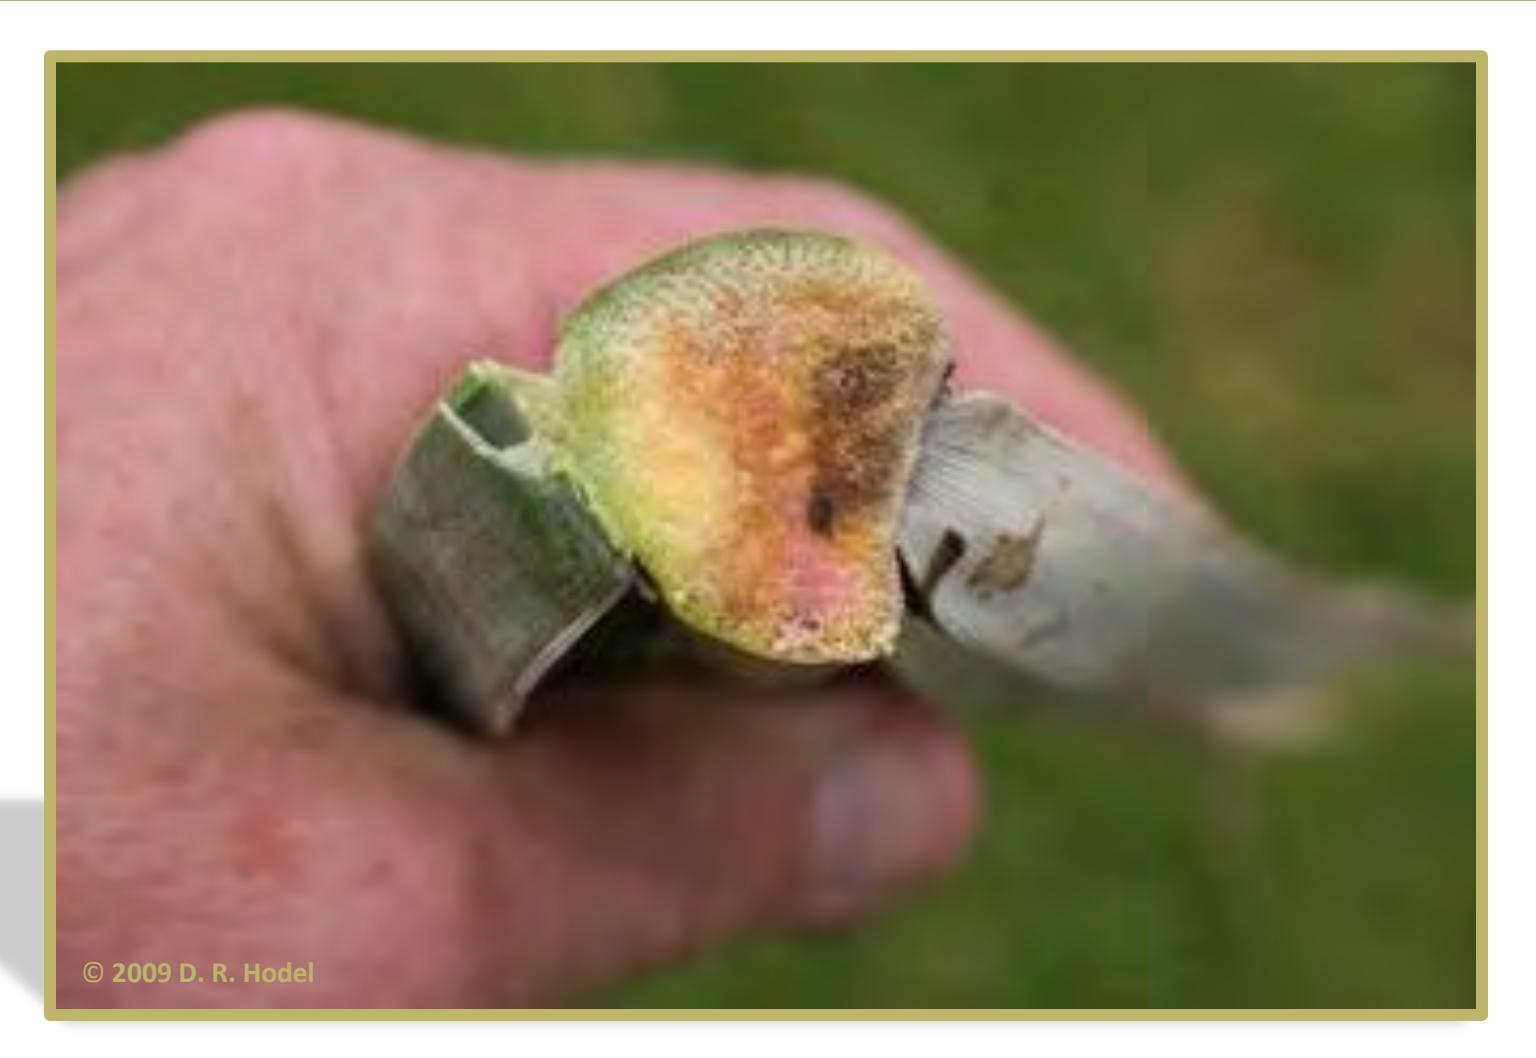
# Petioles and rachises with Fusarium wilt typically show pink/reddish brown internal vascular discoloration

- Extremely water stressed palms can also have similar symptoms to Fusarium wilt
- Symptoms are most pronounced during higher temperatures and greater water demand
  - "Rapid Decline" stage of diseased induced

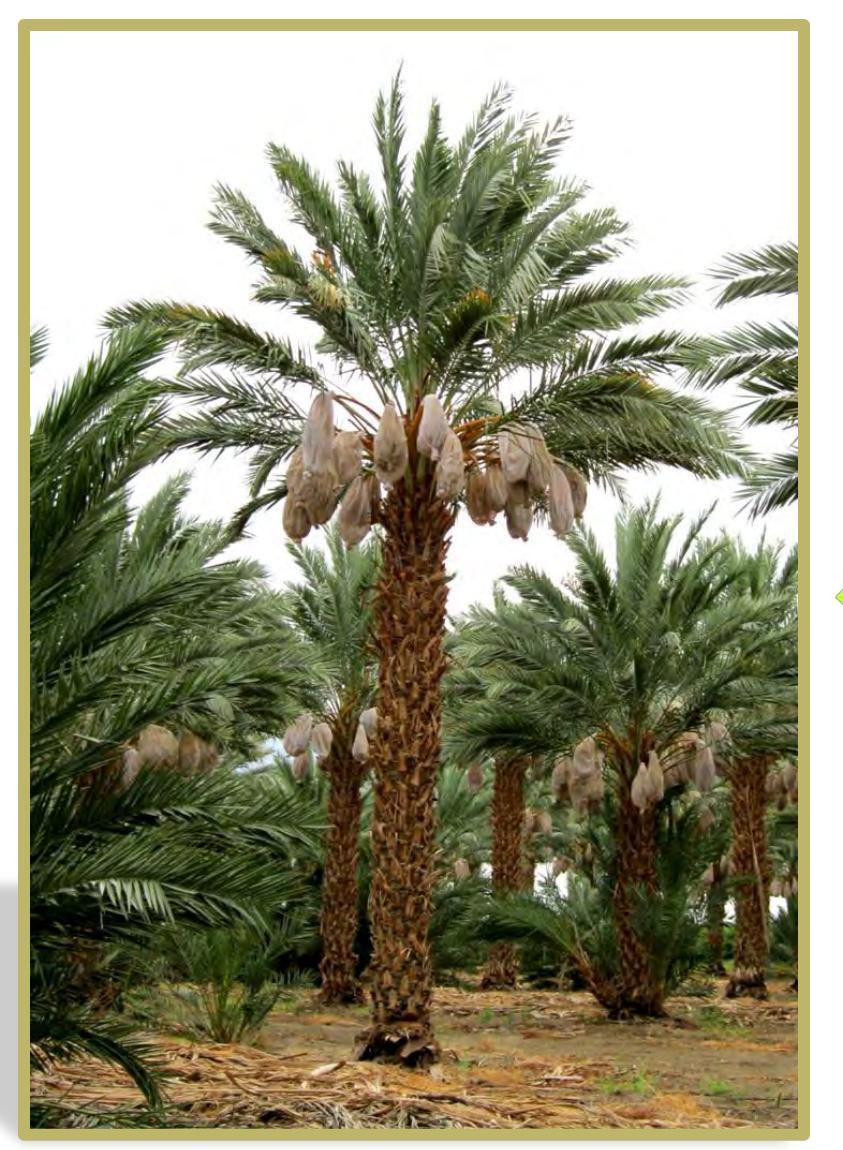
Phoenix canariensis

#### Phoenix dactylifera

(True date) appears to be highly resistant to the disease, and is the species we are using to replace trees on the Embarcadero.
